P/N: 902387-1, Rev. G

P-3 Nose Gear Drag Strut Assembly Upgrade

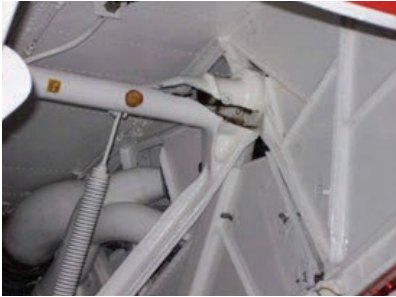
Before

The P-3 Nose Gear Drag Strut is prone to hidden corrosion and fatigue cracks which can lead to fracture and potential nose gear collapse. It is in service with launch customer Royal Australian Air Force. We have partnered with Snowline Aerospace, Inc., to manufacture replacement struts to prevent possible gear collapse. These are U.S. Navy approved direct replacements.

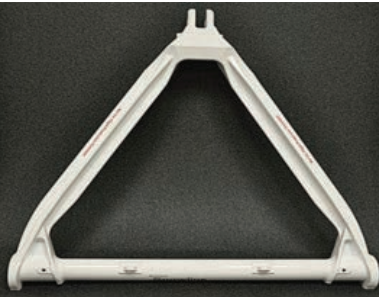
After

Drag Strut Material	Use of 7050-T7451 aluminum plate is more corrosion resistant than the 7049 forging
Drag Strut Coatings	Change to an anodized finish per Mil-A-8625, Type III, Class 1, .001 thick
Drag Strut Bushings	Material change to aircraft alloy 8620. Typical uses for this alloy are gears, ring gears, shafts and crankshafts

- » High-Grade machined aluminum versus traditional forging
- » Load stress points re-distributed to minimize structural stress
- » Robust design and specialized material to resist corrosive environment
- » Lockheed Martin Certified Parts Provider approved
